Slinden Services Ltd

Cast Iron Welding & Metal Stitching Repairs

Fi Fi Pump Casing Cover

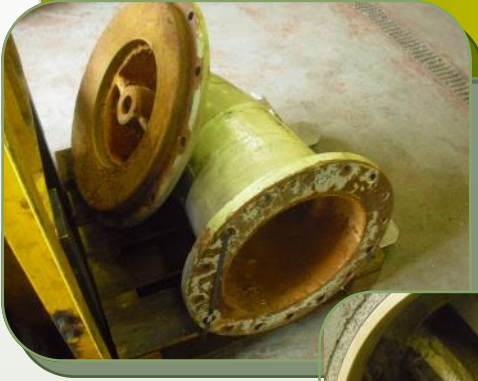
A request came in from a worldwide marine company for us to inspect a fire fighting pump casing cover whilst their vessel was undergoing repair.

We found the casing to have substantial cavitation, and also required the remanufacture and fitting of its bronze nose ring.
