Slinden Services Ltd

NER Water Crane & Handle

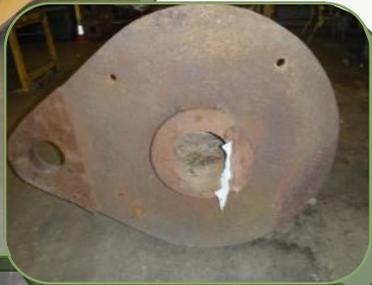
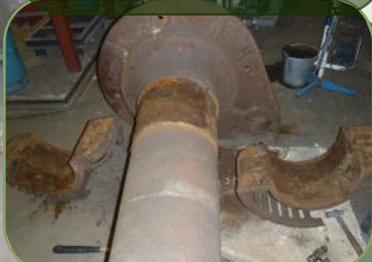
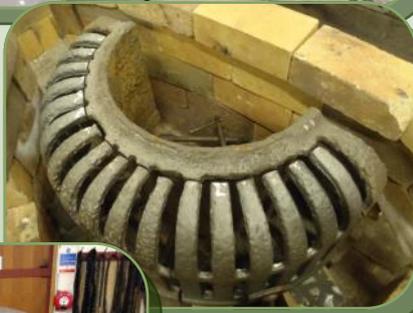
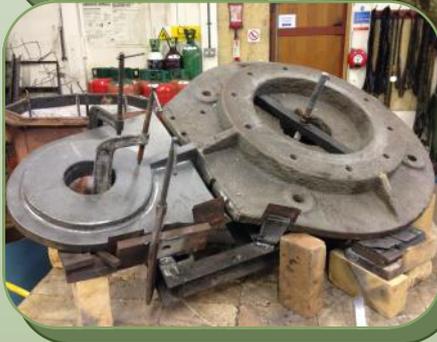
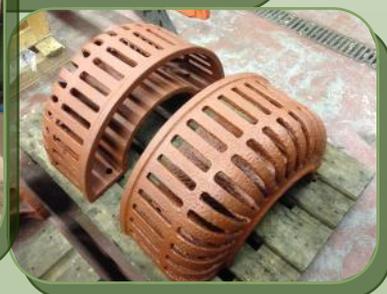
When the water crane arrived in our Derbyshire workshop, all the components were disassembled, shot blasted and crack tested, ready to begin the process of rebuilding.

A rare feature of this water crane was the fire basket, which would prevent water from freezing in extreme cold temperatures, and also stop the cast iron from cracking...many of the original fire bars were missing, so a pattern was made from a good part of the casting and sent away to our trusted foundry to have the basket recast. Once cast, it was welded in and ground to shape before shot blasting and painting with red oxide primer and undercoat.

The original baseplate would have been extended and the handle controlling water flow on the same base...as they now had separate bases, it was decided to redesign and make a pattern to what would have been the original shape, and again, the foundry cast up this part, which was welded to the column's base seamlessly!

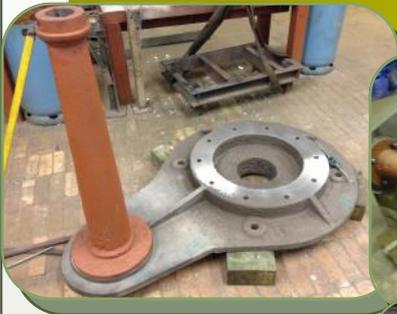
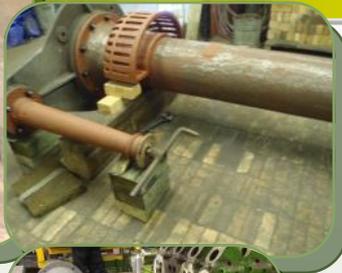
Modifications were then made to the base of the handle to fit the new base, and underground valves and pipes for the water flow to water crane were introduced below the main base plate, followed by pressure testing of all these parts.

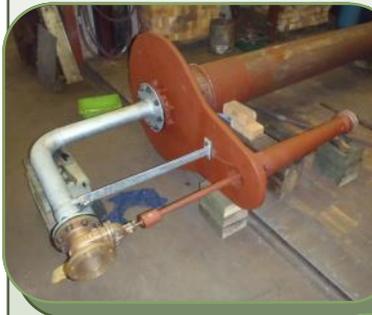
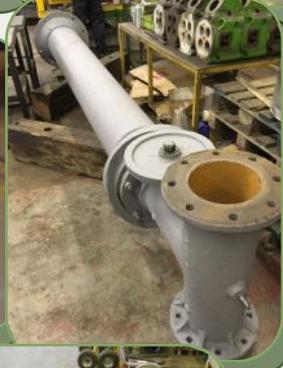
A main component which was missing was the elegant "swan neck" – the section which sits on top of the column and extends horizontally to carry water from the column to the loco tank. Again, a pattern was made and the swan neck cast, before machining and aging. We also redesigned and manufactured the finial and bracing which allows the counter-balance and swan neck to swing in any direction effortlessly.

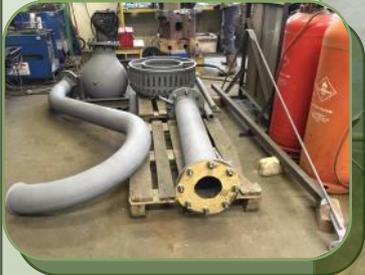
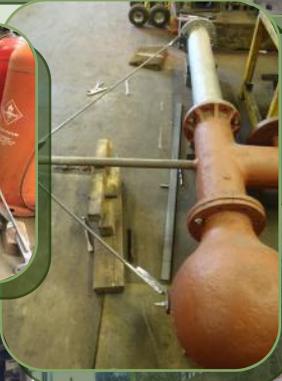
The water crane will now feed water from the newly restored water tower to the steam locos just off the end of the platform at Kirkby Stephen East Station, for their many visitors to enjoy watching an authentic part of steam railway history in action!
