Slinden Services Ltd

Cast Iron Welding & Metal Stitching Repairs

Victorian Water Hoppers

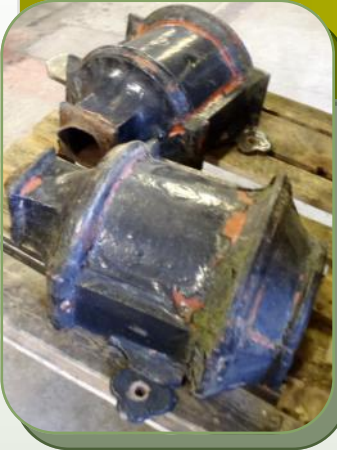
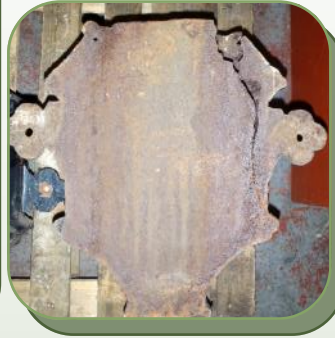
We were contacted by a company who were renovating a Victorian property to repair two cast iron water hoppers which were in need of new spigot sections, and one of them had a large crack to the back face which would need fusion welding.
