Slinden Services Ltd

Cast Iron Welding and Engineering

Zetor Engine

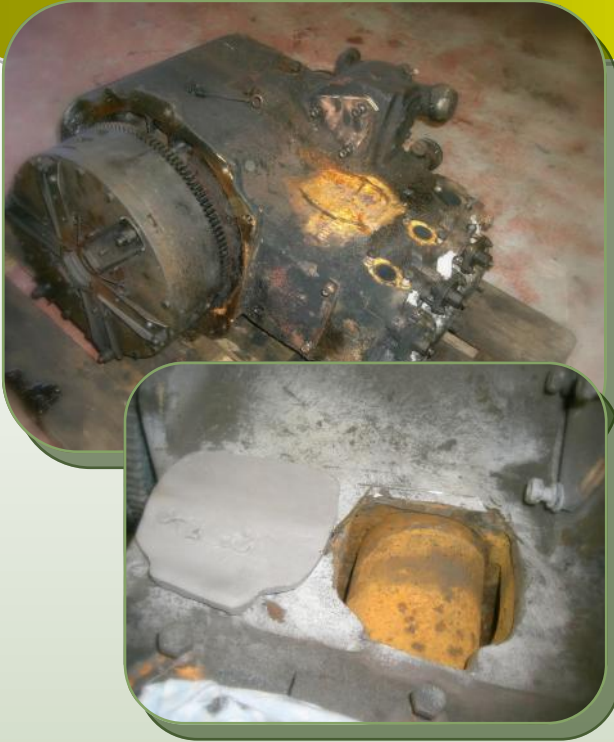
A Zetor Engine was in need of some T.L.C when it arrived at our factory.

As you can see from the photographs this block was badly frost damaged - but with our lock and pin procedures we managed to *breathe new life* into this engine, that otherwise would have been beyond repair.

The frost damaged water jacket was removed, this enabled us to manufacture a new side plate which was applied by our Lock and Pin method for repair.

This repair was a great success!
