# Slinden Services Ltd

Cast Iron Welding & Metal Stitching Repairs

## Ornate Window Grille

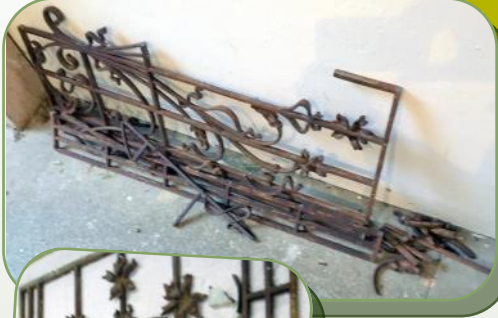
We were approached by a customer with an ornate cast iron window grille that had shattered meaning lots of the finer details had been broken off, needing our help to repair and restore it back to its former glory!

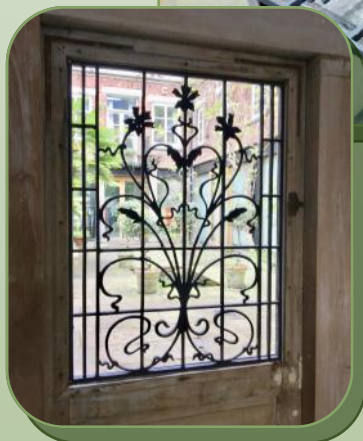
*"Many thanks for doing such an excellent job. Here's the window grille back in it's door."*
