Slinden Services Ltd

LeFort 600 Shear Head

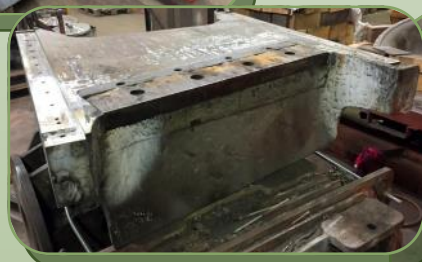
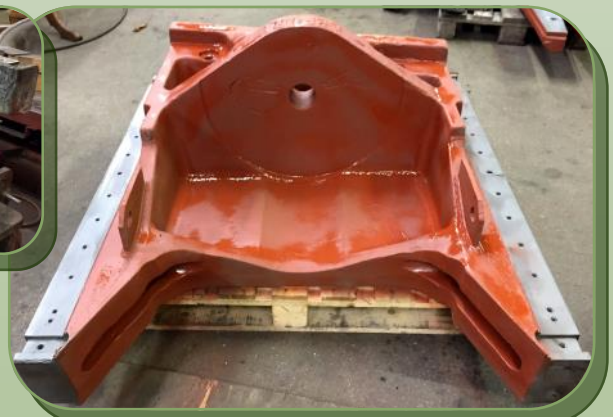
We were approached by an international scrap metal exporters when their LeFort 600 Shear Head needed urgent repairs, due to cracks and wear from daily usage.

When it came to our workshop the head was completely stripped down, removing the blades and wear plates, before undertaking repairs by way of our approved fusion welding procedures for cast steel, grinding up all welds to the correct profile to match existing shape, and fully crack tested.

After the welding and inspection process, we machined all faces before the drilling and tapping of missing bolt holes that hold the wear plates.

The Shear Head was then shot blasted followed by painting with a coat of red oxide primer before a final inspection, and collection by the customer.
