Slinden Services Ltd

Cast Iron Welding & Metal Stitching Repairs

MAK 6M43C Cylinder Head

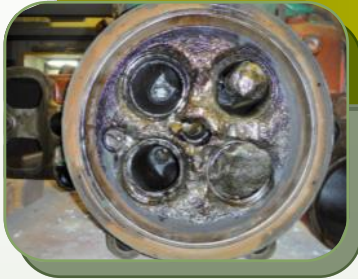
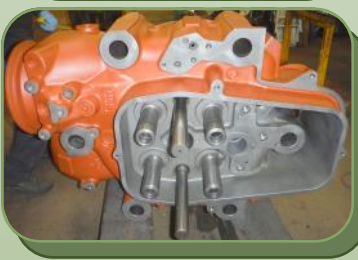
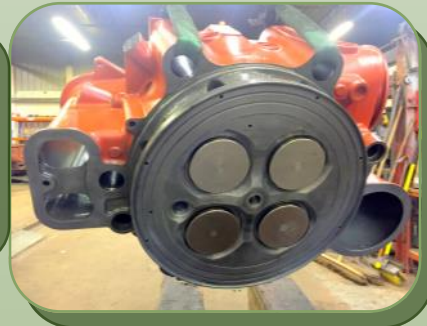
We were contacted by the owners of an Italian merchant vessel operating in European waters to overhaul one of its cylinder heads. It had suffered valve failure either through fatigue or old age, causing extensive damage to the injector, all valve seats and the air start. We organised collection of the head whilst the ship was in port in the South of France for transportation to our Derbyshire workshop where we carried out a complete overhaul.

After an initial inspection, all old and damaged valves and guides were removed, including valve seat inserts, injector tube, and air start assembly.

Damaged areas were then ground back to remove all cracks and subsequently welded following our Lloyds approved fusion welding procedures for cast iron, to all damaged areas including welding of all 4 valve insert pockets. This area was then machined back to standard dimensions and spares fitted. Pressure testing to 10 bar ensured satisfactory repairs had been undertaken. Thorough cleaning followed, before grinding and lapping of new valve seat valves, and fitting and lapping of the air start valve.

After final inspection, the head was painted as required, before liaising with the operators as to where and when we would need to meet the ship with the head.
