Slinden Services Ltd

Cast Iron Welding & Metal Stitching Repairs

Steam Pump & Cylinder Cover

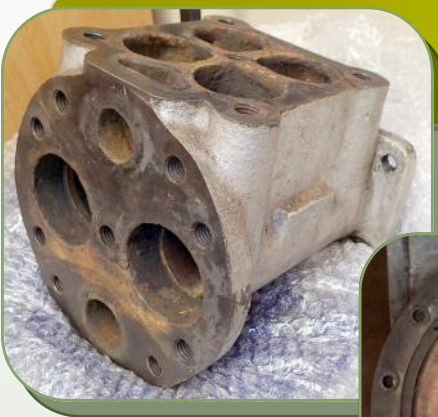
We were approached by the team of a historical steam ship to carry out emergency repairs to the auxiliary steam pump and main cylinder steam cover within a tight time frame, ready for this season's first planned events, allowing time for return transportation and rebuild!

The pump was cracked in a few areas, and the cover was also cracked around the outer rim, following through several of the mounting holes.

After any remaining parts were carefully removed, repairs were undertaken by way of our Lloyd's approved fusion welding procedures for cast iron. We then ground up all the welds to the correct profile, matching existing shape, before fully crack testing the components, and refitting of any removed parts.
