Slinden Services Ltd

Cast Iron Welding & Metal Stitching Repairs

Superheater Header

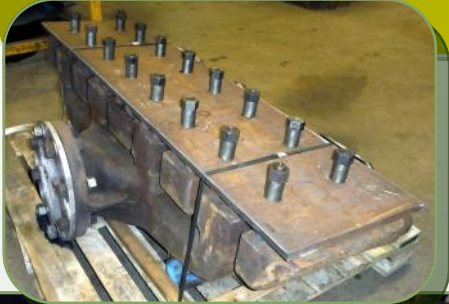
We were contacted by another vintage railway regarding a steam loco superheater header which was found to have a crack across a flange face, through a stud hole and into the body.

We arranged collection from the station, and once in our workshop, a thorough inspection found two more large cracks needing attention.

We undertook the welding repairs by way of our Lloyd's approved fusion welding procedures, grinding up all the

welds to the correct profiles to match existing shape, and fully crack testing. This was followed by machining flanges flat, re-drilling and tapping the one welded hole, and machining the tube landings to correct tolerances. A hydraulic pressure test was undertaken before a coating of red oxide primer was applied, ready for dispatch to the Railway.
