Slinden Services Ltd

Cast Iron Welding & Metal Stitching Repairs

Cast Iron Windlass Bedplate

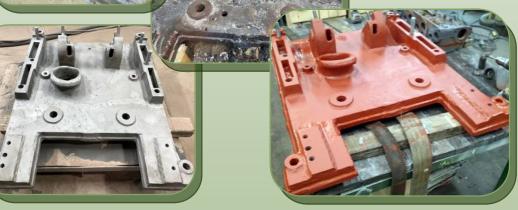
"We have a crack in our cast iron windlass bedplate which has previously

had a metalock type repair that has not lasted. With your vast experience in this field, do you think you can repair it by your welding methods?"

The bedplate was transported to our Derbyshire workshop, where it was inspected and crack tested, before all the old stitching repairs were removed. Repairs were undertaken by way of our Lloyds approved fusion welding procedures for cast iron,

before being ground to the correct profile to required specifications. Then

it was blasted, fully crack tested to SNT TC 1A, and given a coat of primer. A final inspection was carried out, before collection by the customer.
