# Slinden Services Ltd

## AMILCAR

Slinden Services Ltd were approached to repair an Amilcar Cylinder Block recently.

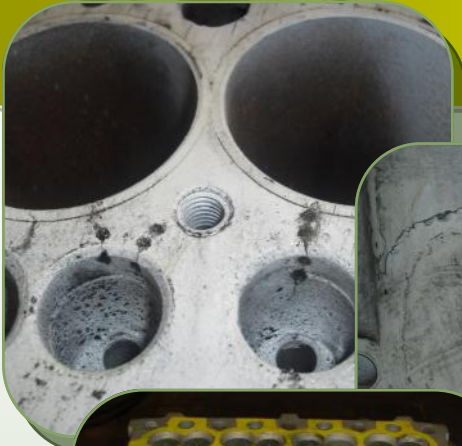
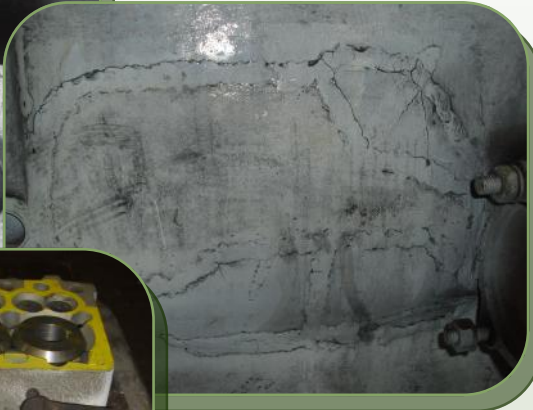
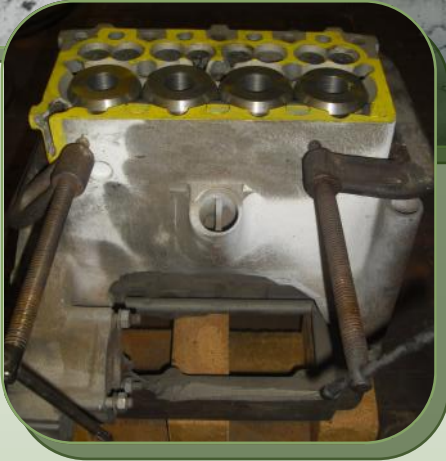
After inspection of the Block it was found to have previous failed repairs, extensive cracking on the head face area and cracks between all the cylinder bores!

As no job is too big for our team, we set about carrying out the repairs. This involved manufacture of new cylinders and pre-machining the block to accept the new cylinders, followed by

welding using our approved Fusion welding technique, including welding of all cracks, frost damage and previous poor quality welding.
