Slinden Services Ltd

Cast Iron Welding & Metal Stitching Repairs

Cast Iron Window Balcony

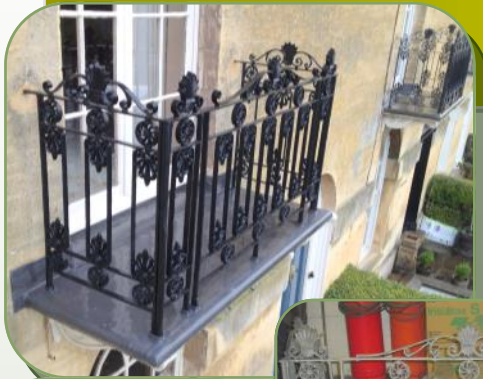
When a query came in to us for repair and restoration of an ornate cast iron balcony, our engineer attended an on site inspection before bringing back to our workshop.

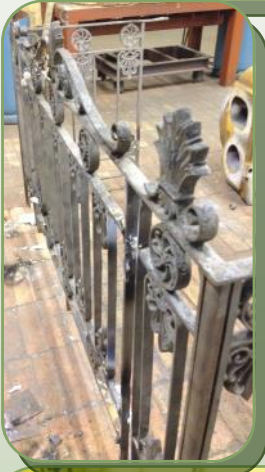
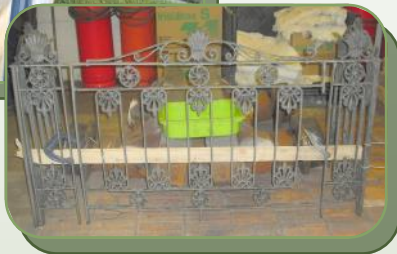
We found missing scrolls and bars as well as general cracks that needed welding, and modifications would also be required to the feet and wall fixings to allow for safer installation into the base and wall.

We carried out welding repairs by way of our Lloyds approved fusion welding procedures, giving a repair as strong if not stronger than the original material, also manufacturing the missing parts and making the modifications where necessary.
