# Slinden Services Ltd

## 1932 Alvis Firefly Head

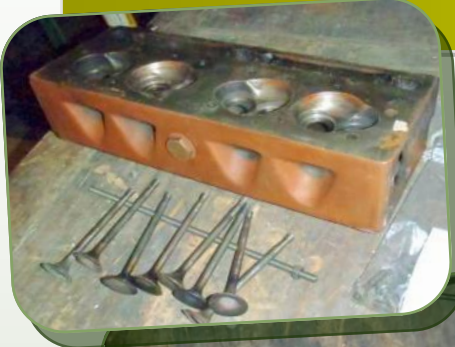
We were contacted by the owner of a 1932 Alvis Firefly cylinder head who explained that after many years excellent service the head had developed a water leak from below the valve inserts on the two centre exhaust ports from corrosion, age and heat.
