Slinden Services Ltd

Cast Iron Welding & Metal Stitching Repairs

Class B12 Cross Head Top Plate

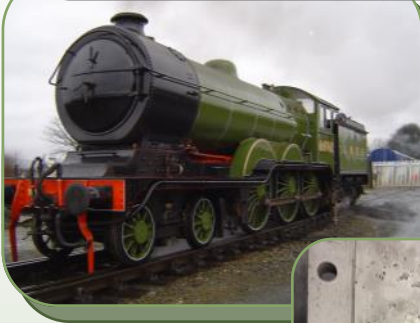
We were contacted by the owners of the only surviving Class B12 Locomotive No. 8572 to undertake the repair of its cross head top plate, which had casting faults from manufacture, as well as cracks, and worn faces due to being machined a number of times over the years reducing their thickness.

Upon receipt in our Derbyshire workshop, the top plate was inspected and crack tested before undertaking welding

repairs using our Lloyds approved fusion welding procedures, post weld grinding and dressing of all welds where not machined, before machining back to original LNER drawing dimensions. This was followed by blasting, a coating of red oxide primer and final inspection.
