Slinden Services Ltd

Cast Iron Welding & Metal Stitching Repairs

Cylinder End Cover

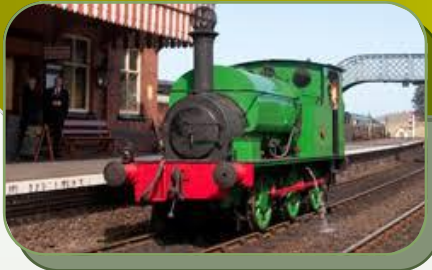
When our customer sent us a cylinder end cover off a steam loco, we set about inspection and crack testing which found the bolt hole lug was cracked, needing weld repair.

We undertook repairs by way of our Lloyds approved fusion welding procedures for cast iron, giving a repair as strong (if not stronger) than the original material. We then ground up all welds to the correct profile and fully crack tested, followed by shot blasting and a coat of red oxide primer, before dispatch back to the customer for machining and refit.
