# Slinden Services Ltd

## Industrial Gearbox Cover

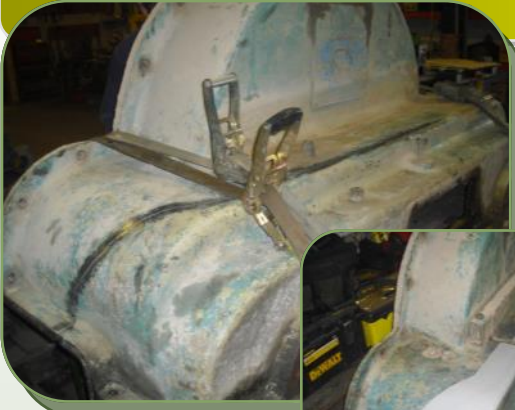
When a Yorkshire engineering company contacted us requesting our help with urgent repairs to a 50” crack to the gearbox cover from an industrial machine—with the minimum amount of time out of action—we were ready for the challenge!

The gearbox cover was brought to our workshop where our engineers undertook emergency repairs to the crack using our approved metal stitching procedures, followed by grinding up to the correct profile, and fully crack testing. After the stitching and inspection process the repaired area was primed ready for the refit, enabling the machine to continue its service with the minimum of disruption, and at a fraction of the cost of replacement.
