# Slinden Services Ltd

Cast Iron Welding & Metal Stitching Repairs

## Tees Tidal Gates

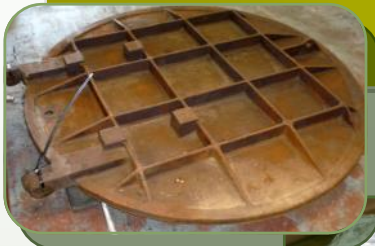
We were approached by a Teesside company who called upon our services to weld repair two cast iron tidal gates which had broken lugs and also needed building up and realignment of the lug bores and machining back to size, as the bores had become oversized over time. The repairs had become necessary as part of a major redevelopment and regeneration program for the area.

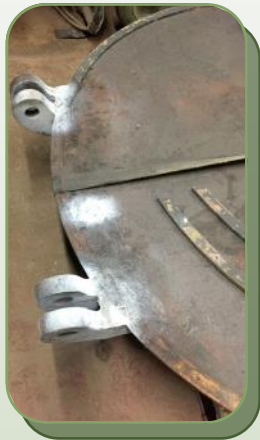
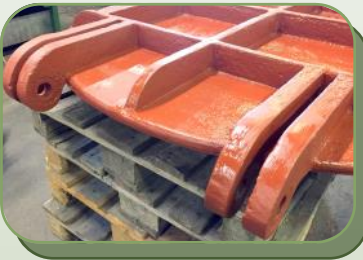
Upon inspection, it was also found that the brass sealing faces had come away due to corrosion of the holding pins. Both gates were crack tested before undertaking repairs by way of our Lloyd's approved fusion welding procedures for cast iron, giving a repair as strong – if not stronger – than the original material. The sealing faces were refitted as required with stainless steel studs. This was followed by grinding up of all welds to the correct profile to match existing shape and again

crack testing.

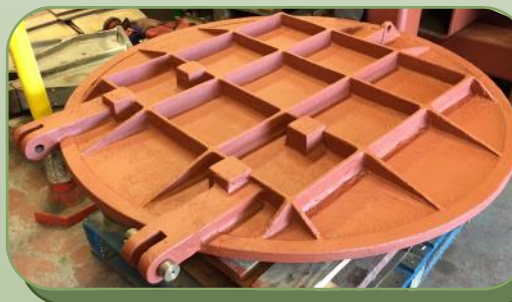
Next came the re-drilling and re-aligning of the lug bores, ensuring to correct size and the brass link pins provided were a good fit, followed by shot blasting and a coating of red oxide primer before customer collection.
