Slinden Services Ltd

Cast Iron Welding & Metal Stitching Repairs

Village Water Pump

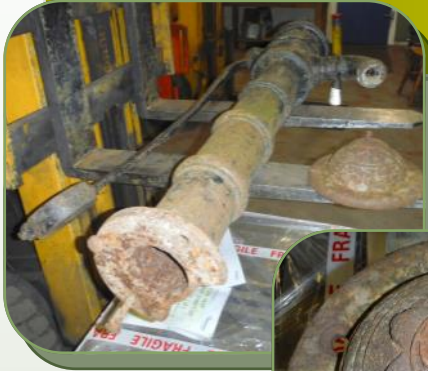
We were contacted by a customer who had acquired an old cast iron village pump which was in need of some TLC. The foot of the pump had part of the base flange missing, and the top of the pump was short of its original cap and finial!

Fortunately, the customer was given a cap on loan, so that a pattern could be made and a new one cast by our preferred foundry (alongside a new finial), whilst we carried out repairs to the base flange by way of our fusion welding procedure. This was followed by the repairs

being ground to shape, shot blasting, and all finished parts painted with a red oxide primer before customer collection.
